**Scientific Research Centre of the
Slovenian Academy of Sciences and Arts**

Log pod Mangartom Landslide, Slovenia

»Space and Major Disasters«

Final Report

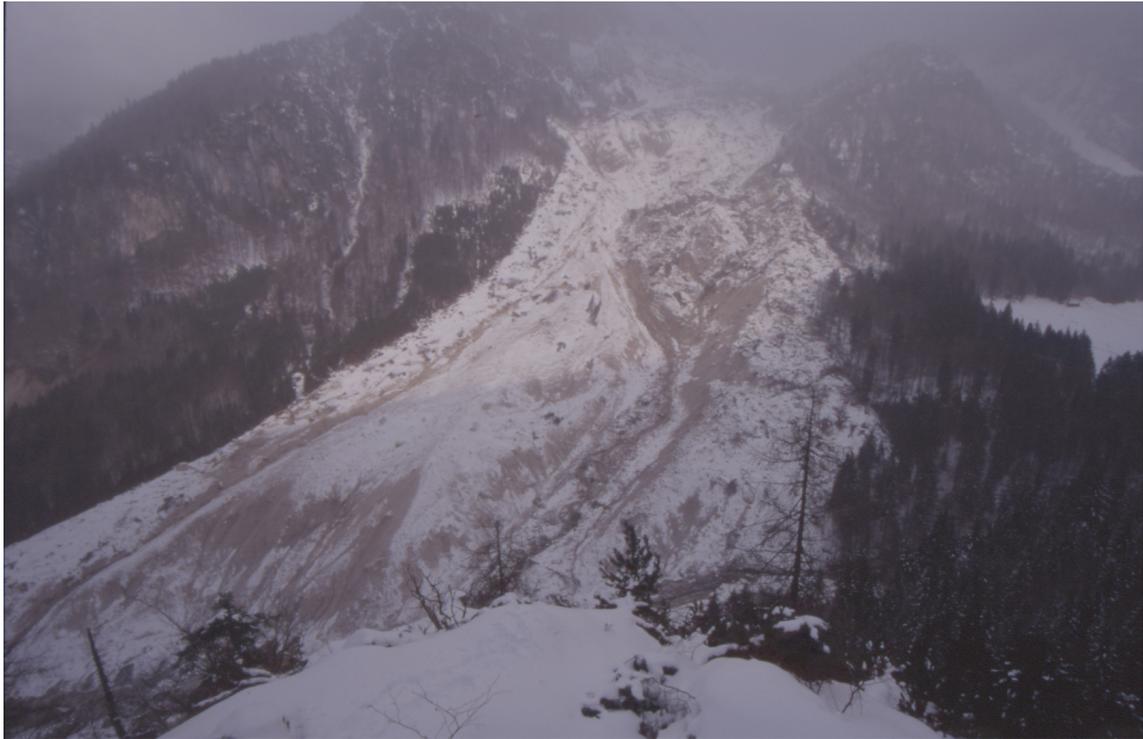
Figure 2: Part of the landslide covered with snow (photo J. Mlekuž).

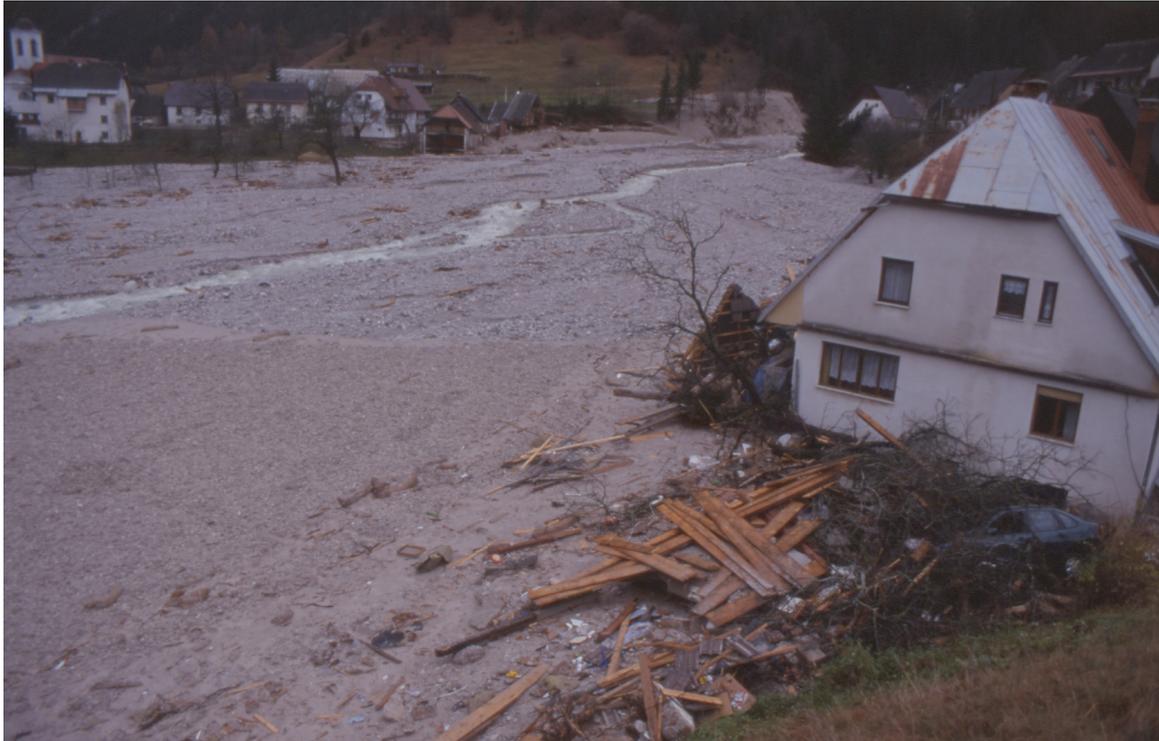
Figure 3: The village of Log pod Mangartom destroyed by a landslide (photo J. Mlekuž).
